Postharvest Handling Technical Bulletin

HOT WATER TREATMENT FOR REDUCING ANTHRACNOSE DECAY OF MANGOES

Postharvest Care and Market Preparation

Technical Bulletin No. 5

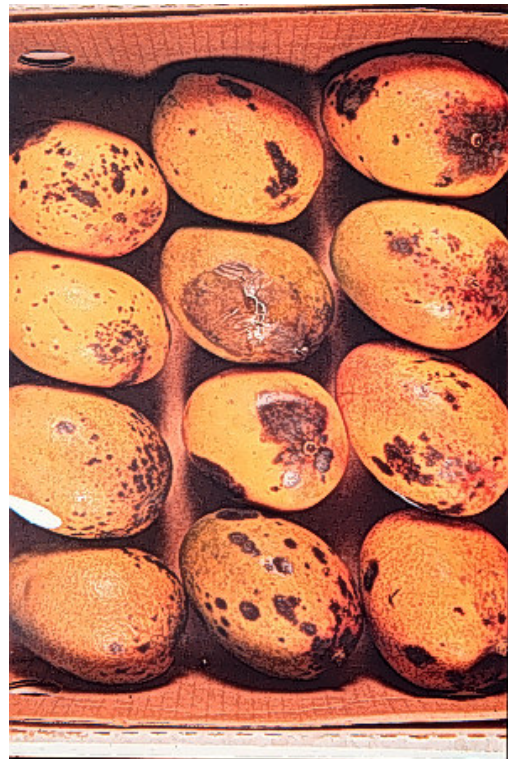
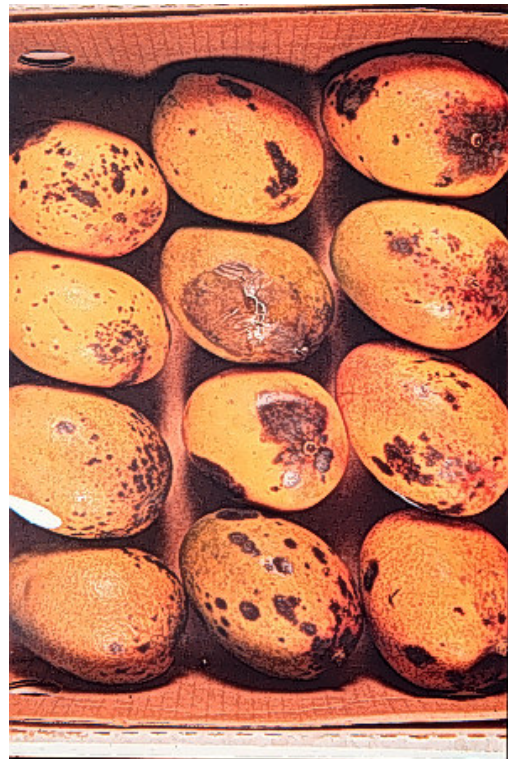
Figure 2. Large black anthracnose lesions on ripe mango fruit.

Anthracnose (*Colletotrichum gleosporioides*) is the worst postharvest disease of mangoes in Guyana and is the fungal organism responsible for the vast majority of rejected fruit. Initial symptoms of this disease include sunken black spots on the surface of the fruit (Figure 1) which enlarge to form huge black lesions as the fruit ripens (Figure 2).

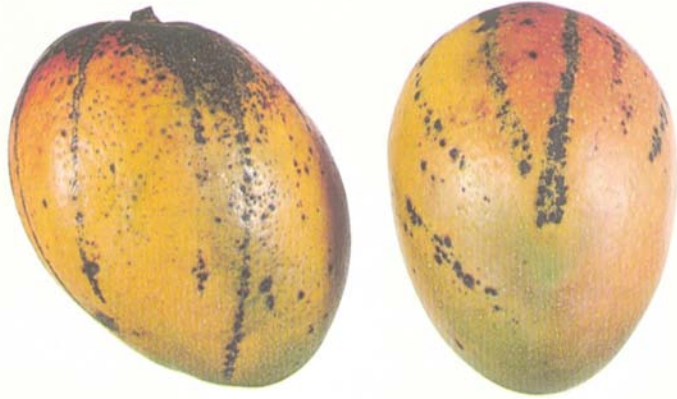
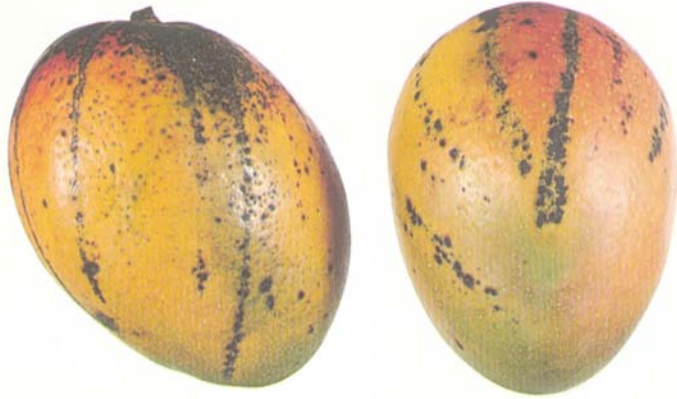
Figure 3. Tear-drop pattern of anthracnose development on mango fruit.

A tear-drop pattern of black spots running length-wise down the fruit is common due to dispersion of the fungal spores by raindrops (Figure. 3).

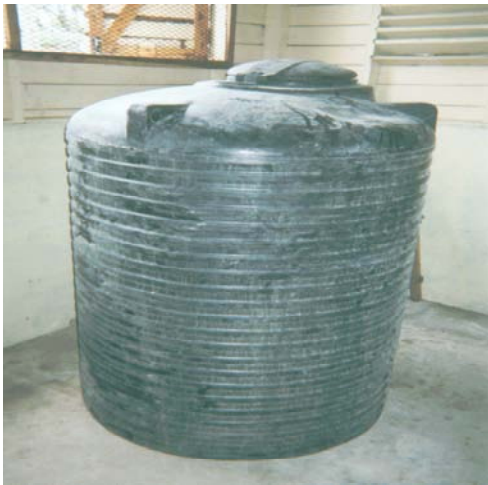
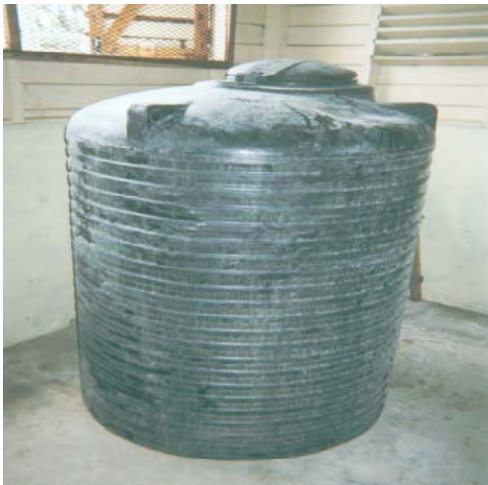
Figure 4. Polyethylene tank commonly used for water storage.

One of the quickest and least expensive ways to construct a hot water treatment facility in Guyana is to use a large polyethylene tank [Tuf-Tank (Figure X)] with the top cut off, or a ceramic-lined cement trough. The Tuf-Tank is imported from Trinidad and available from a number of vendors in Georgetown (Figure 4). Polyethylene is less expensive than other types of plastic polymers. Polyethylene is stable up to 65°C (150°F), which is above the hot water temperature needed to treat mangoes. Other relatively inexpensive materials amenable to fabrication as hot water tanks include concrete and bricks lined with ceramic tiles.

Polyethylene tank (460 gallon or 1740 l size)

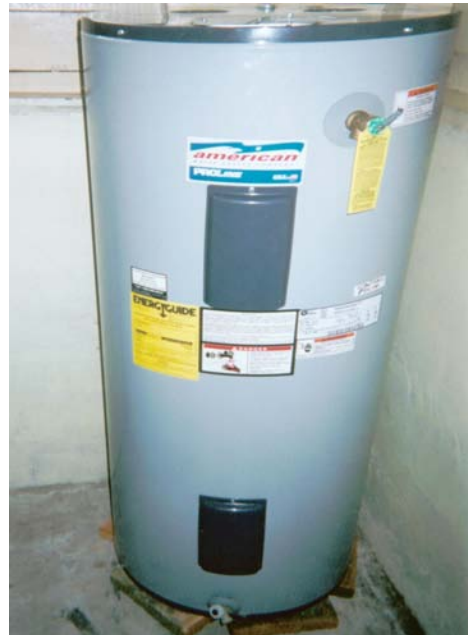
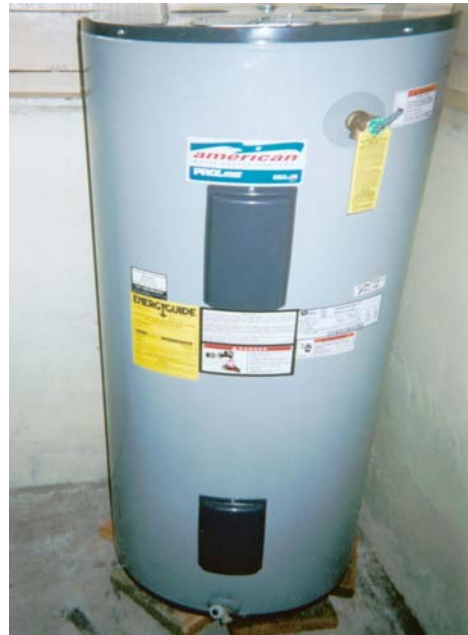
Figure 5. Commercial hot water heater used to heat the water tank.

The water must be heated with either electric or gas heating elements. The least complicated and most uniform heating elements are electric. They can be installed in the hot water tank along the bottom and perimeter, or external to the tank, in the form of a commercial hot water heater (Figure 5). If the electric heating elements are installed inside the tank, it will be essential to protect and shield them from directly contacting the containers of mango fruit. Also, an experienced electrician and/or plumber will be needed to be hired to ensure the reliability and safety of the system. If a self-enclosed hot water

Hot water heater (65 gallon or 246 l)

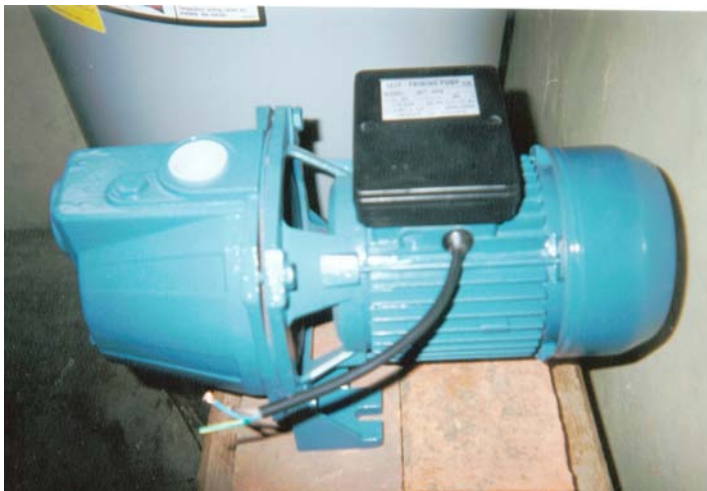
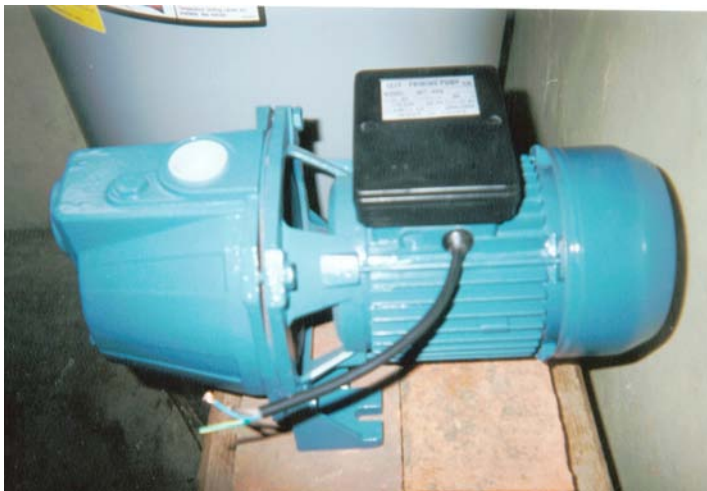
Figure 6. Water pump used for circulating water from the hot water heater to the tank.

The hot water must be circulated in the tank with a sufficiently high flow to ensure uniformity of temperature. Therefore, a water pump of adequate flow rate capacity and tolerance to at least 52°C (126°F) water is needed. Several commercial hardware stores in Georgetown sell these types of water pumps (Figure 6). Additional accessories which will be needed to complete the hot water treatment unit include high-temperature resistant PVC pipe, shut-off valves, silicon sealant, and an in-line water filter.

Water pump (65 liters/min. flow)

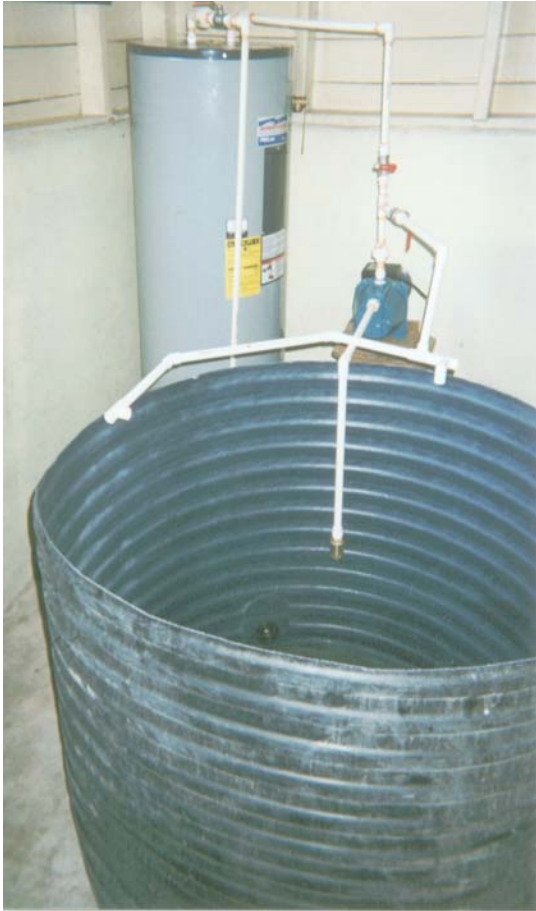
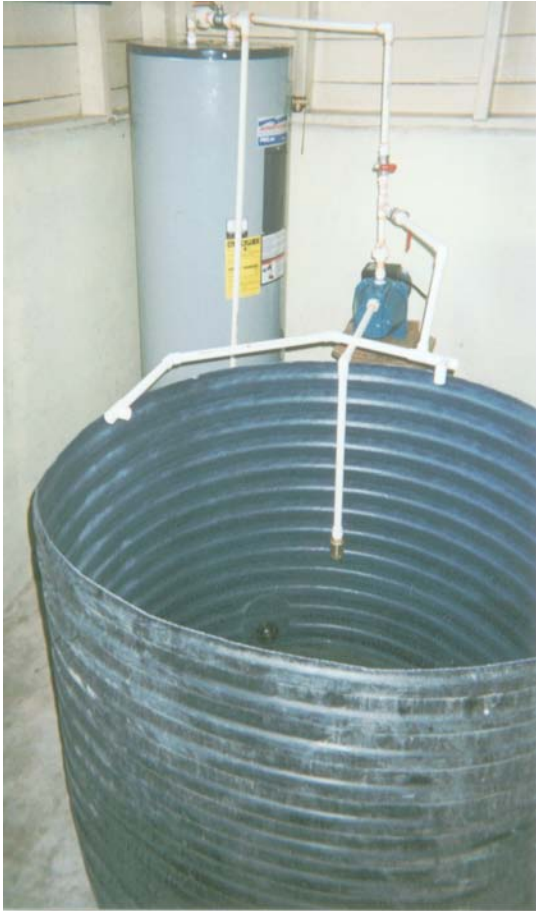
Figure 7. Front view (without water) of hot water treatment unit at the NGMC packinghouse. Note: plumbing of PVC pipe inside the tank is not completed.

A prototype of this inexpensive hot water treatment unit was constructed at the NGMC packinghouse in the Sophia Exhibition Center Complex (Figures 7 and 8). It is capable of treating approximately 90 kg (200 lb) of mangoes at one time. An ideal container to use for submerging the fruit is made of smooth, rigid plastic and is well ventilated (Figure 9). This type of unit can be constructed within a day. The cost and availability of all the components is indicated below. The cost of labor for the plumbing and electrical wiring is not included, since it will vary according to the individual site and technician capability.

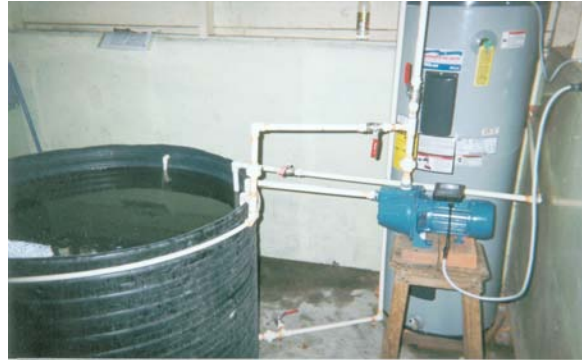
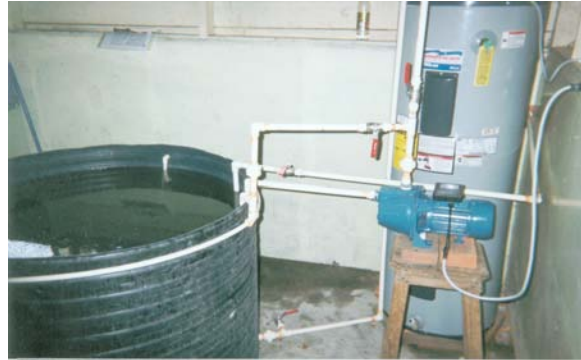
Figure 8. Side view (with water) of hot water treatment unit at the NGMC packinghouse.

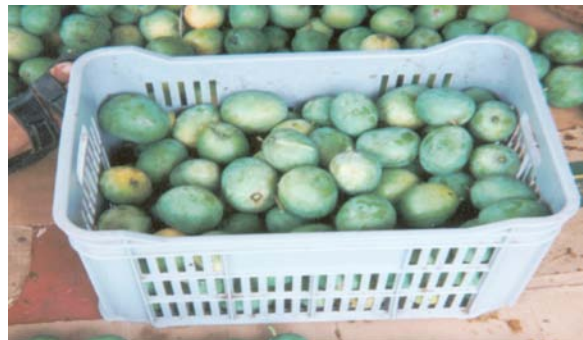
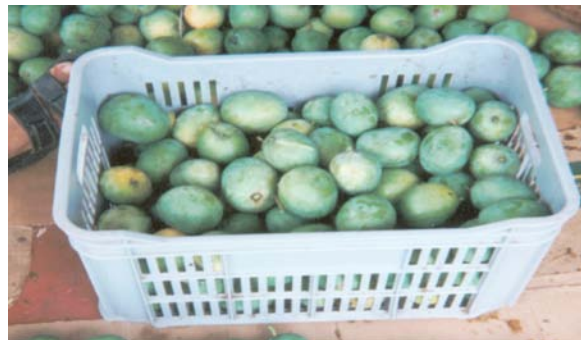
Figure 9. Rigid plastic container ideal for hot water treatment of mango fruit.

Polyethylene containers for mangoes (6 needed per 460-gallon or 1740 liter tank)
